TD **9836/2019**

**Accidental Release of
CO2 System**

SAFETY BULLETIN 12 - Accidental CO₂ releases onboard 2 UK Merchant Vessels

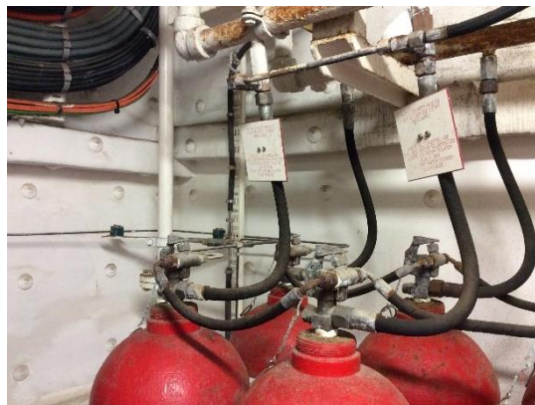
- Many systems are designed such that a single leaking valve can discharge the entire system.
- Lack of clarity on life/service intervals and maintenance requirements of cylinder valves.
- There is perceived over reliance on shore-based contractors who may have poor knowledge of the specific system fitted onboard.
- CO₂ leaked from the systems and was not contained by the pipework and manifold.

Image - Common arrangement of pilot bottles connected to system with flexible pipes

- When bottles are required to be refilled, it is important that valves should be either serviced or replaced at least in line with manufacturers recommendations. With

regards maintenance of the valves the MCA and MAIB would like to draw the attention of service agents and ships operators to BS EN ISO 22434:2011 - Transportable gas cylinders - Inspection and maintenance of cylinder valves which provides relevant guidance on the issue of maintenance where manufacturers are silent on the issue.

- MCA interpretation of MSC.1/Circ.1318 requires that 10% of high pressure CO₂ cylinders are hydrostatically tested at their 10 year anniversary. Furthermore, in line with BS EN 1968-2002 – All remaining cylinders must be hydrostatically tested by the 20 year anniversary.

- Flexible pipework must be replaced at intervals specified by the manufacturer or at the 10 year anniversary whichever is sooner as per MSC.1/Circ.1318.

- The IMO FSS Code, chapter 5.2.1.1.3 requires that crew should be checking quantities of fire extinguishing medium. Given the numbers of bottles involved, methods such as weighing of cylinders are highly impractical. There are now commonly available simple methods such as ultrasonic liquid level gauges which facilitate easy in situ level testing which operators should consider in order that their crews can readily and safely check the levels of CO₂ thus enabling early detection of a potential problem. The UK would consider this appropriate as per the IMO FSS Code Chapter 5.2.1.1.3 and this could be built into the planned maintenance system.

- The MCA would remind operators of the benefit of marking the cylinders and checking CO₂ levels at least annually.
- The MCA would also recommend that operators test and ensure the correct operation of any pressure switches and alarms within their systems.
